Corona Handpiece Sales and Repair, Inc.

Major Causes of Handpiece Failure

By Karl Wiese

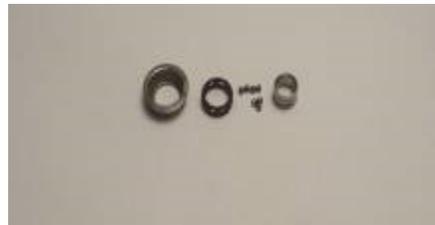
The bearing retainers are made up of high temperature plastic material and are usually Phenolic or Torlon. The retainers hold the bearing balls equally spaced around the inner race. They also are permeated with a light grease to help with continued lubrication.

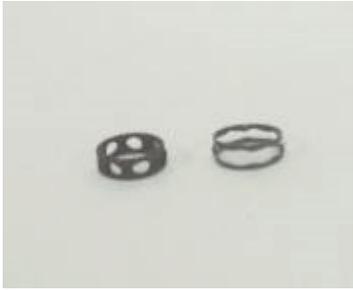
When the air pressure exceeds the recommended settings of 32-35 psi, the bearing will turn greater than the 350,000-420,000 rpms that they are rated for. When this happens the ball bearings that are held equally spaced by the retainer will start to oval the retainer holes.

Eventually one hole will meet the next hole and so on until the retainer will break in half for a complete bearing failure.

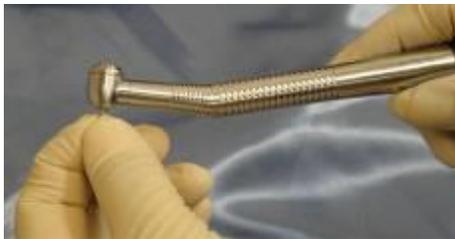
Insert and Twist Bur

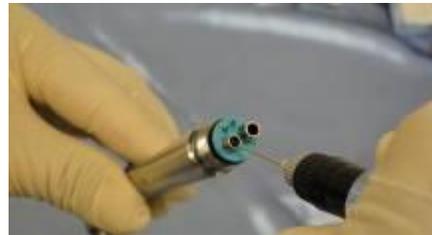
Lubricate Intake Tube

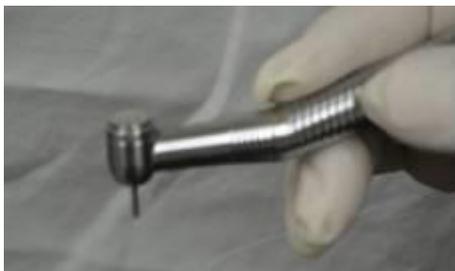
Expel all Lubricant

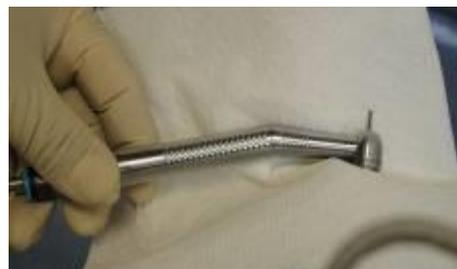
Clean Excess Lubricant
